Lightning and Surge Protection of Photovoltaic Installations

Two Case Histories: Vulcano and Kythnos

François D. Martzloff

June 1989

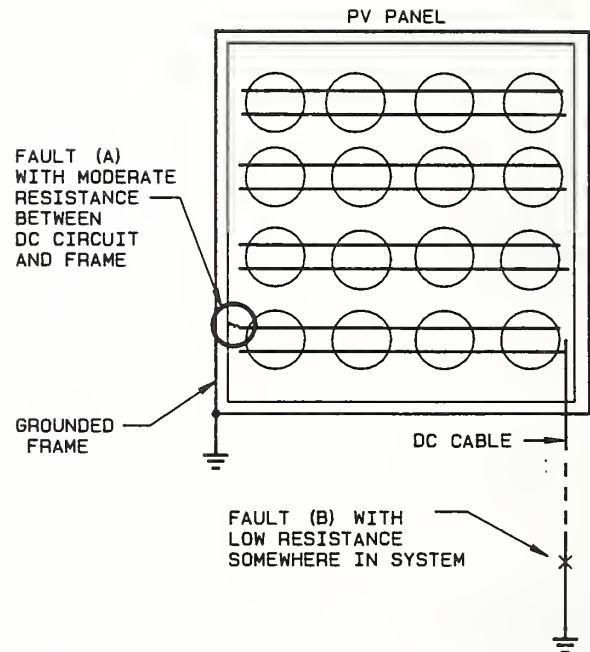
Figure 2-4. Scenario of double ground fault

In view of the reported insulation problems that occurred during the initial period of operation, one might ask whether the damage to that panel might be the result of a leakage of dc current to the frame, rather than the simple direct effect of a lightning strike. This dc leakage might be the consequence of a lightning induced overvoltage stress that created a double fault in one single event, or that created the second fault after the first had previously occurred but remained uncorrected. The scenario could unfold as follows:

In this manner, we have the elements that could create the observed effects, that is, an obvious fault with burning at (A), and a less obvious fault at (B), with a low resistance that may be eliminated during emergency maintenance work following the occurrence of the incident. The likelihood of such a double fault is admittedly low, but cannot be ruled out in view of the design of the ground fault detection system which indicates faults locally only. This scenario, still associated with lightning, would not be in contradiction with the observed low position of the damage since it does not require termination of the strike at that low point of the panel. Furthermore, the low point on the sloped array is also a place where moisture is more likely to accumulate and thus create a good candidate for a contributing cause in the scenario of two-stage insulation breakdown.

A variation on the theme of the double fault might even be that the fault was entirely caused by long-term insulation breakdown, without the "*coup de grace*" administered by the lightning incident. However, the observation of a damaged module soon after a lightning storm would point to the lightning-induced overvoltage scenario.

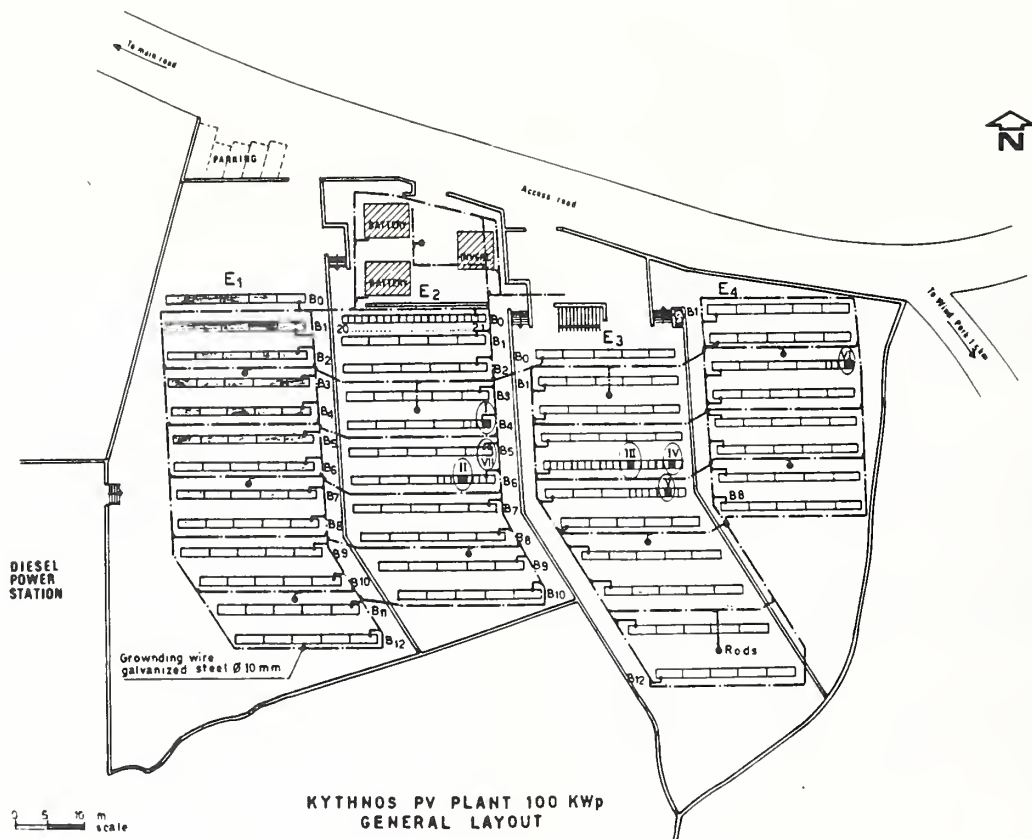
Figure 3-2. Location of ground cables, air terminals, and modules presumed damaged by lightning

Several panel failures have occurred in 1986, 1987, and 1988, which have been attributed to lightning. Lightning rods and surge arresters are provided at this site, making it an interesting subject of study, both for an explanation of the presumed direct strikes occurring in spite of the lightning rods, and for a study of the protection afforded by the surge protective devices installed in the circuits, as well as their failure modes. Further information on the history of panel damage is included in Appendix B.

MODULE - 307 0423 This module was in storage and had been at location E2 B4 1 ("I" on Figure 3-2), 10 m from the nearest air terminal. There are burn marks along both long edges,

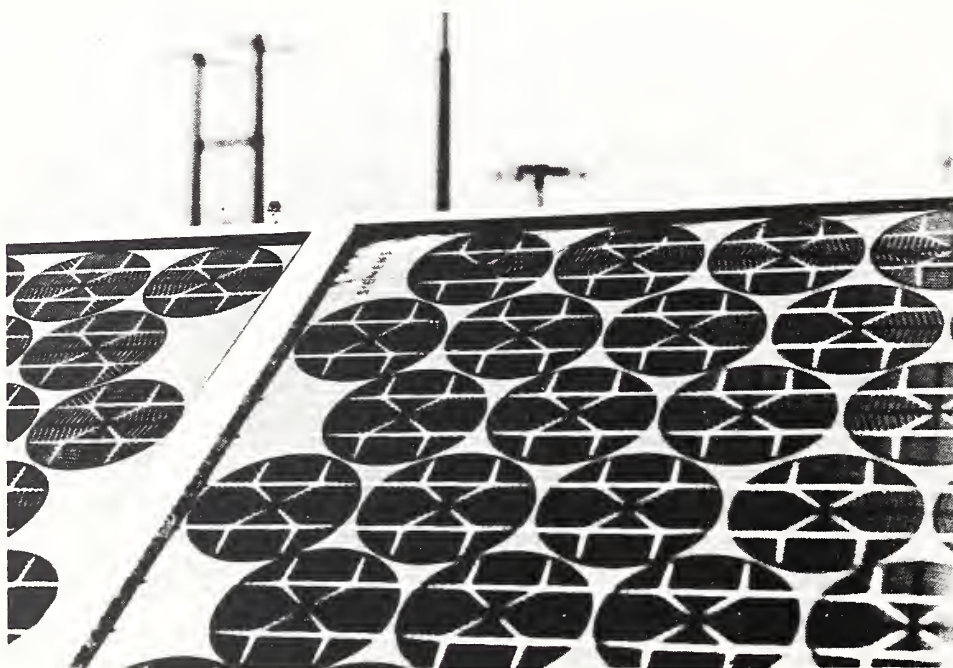
Module E2, B6, 5 damaged by lightning stroke at 5/2/87. Short circuited area along the frame

Module E3, B4, 13 damaged by lightning stroke at 5/2/87. Short circuited area along the frame

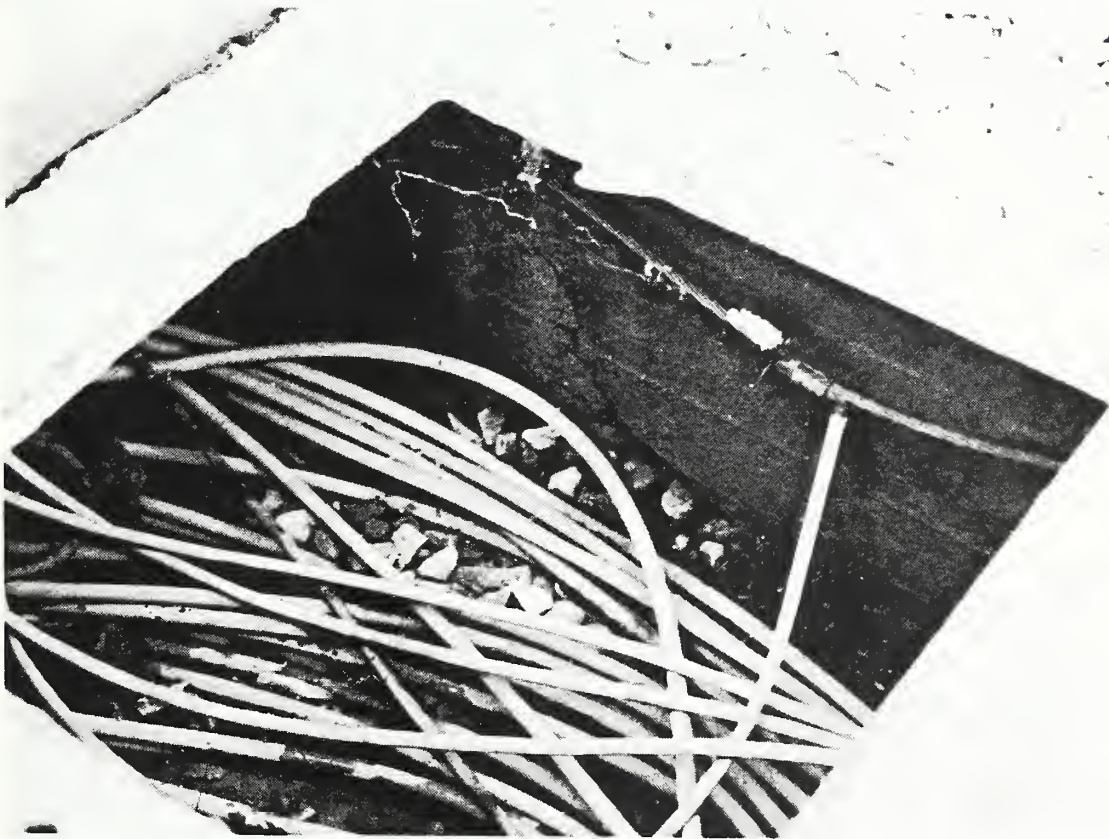
2-4 String terminal box with protective varistors
and blocking diodes

2-5 Pull box in field, showing dc cables and ground cable weld

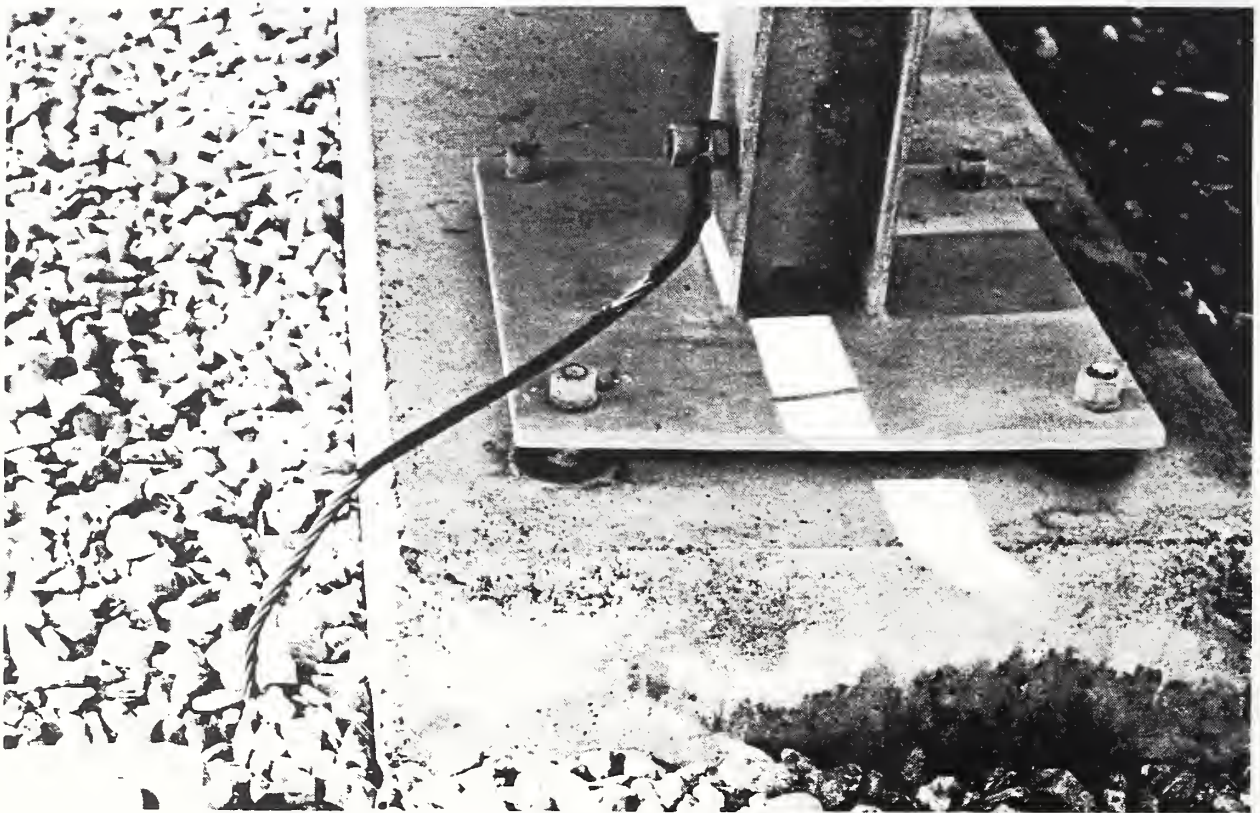
2-6 Side view of array and columns

2-7 Grounding of array column

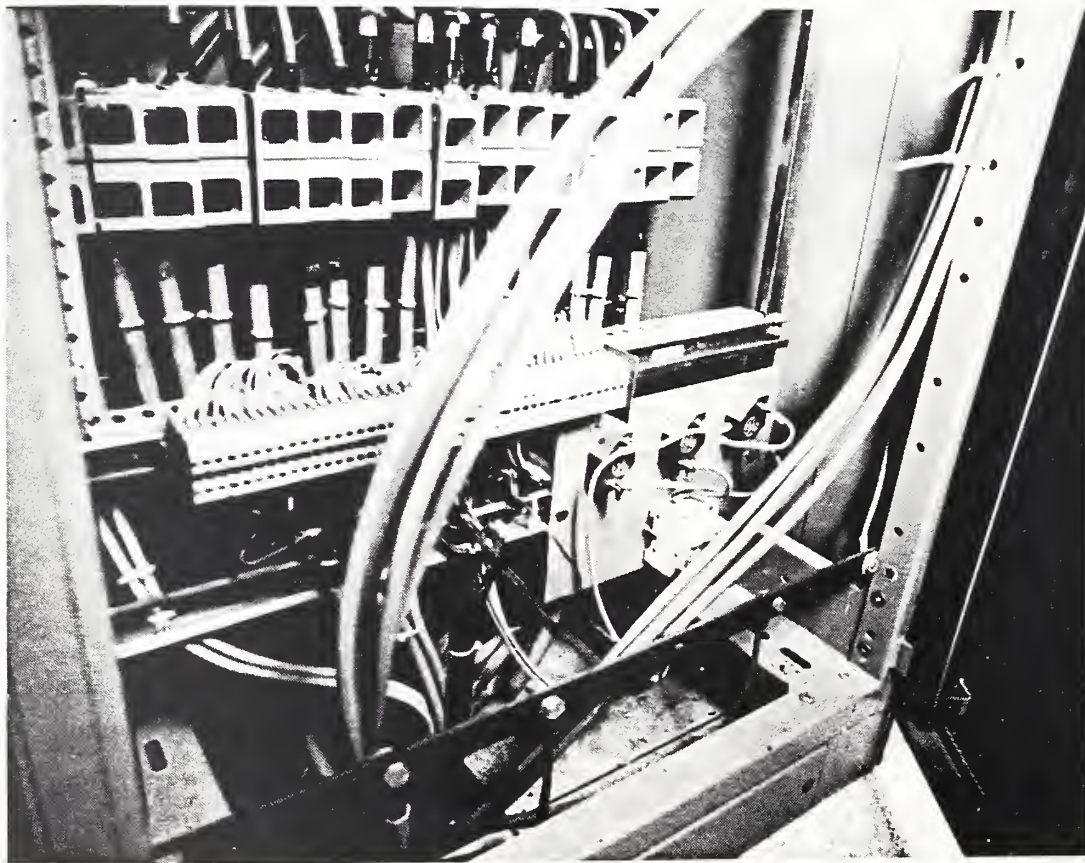
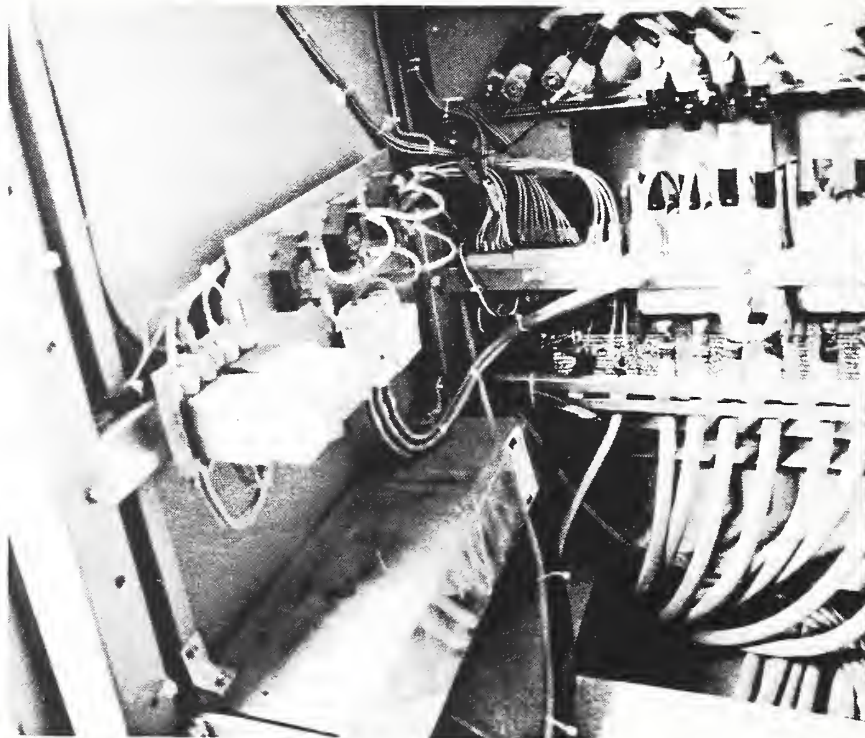
2-9 Field terminal box with dc protection varistors and blocking diode protection varistors

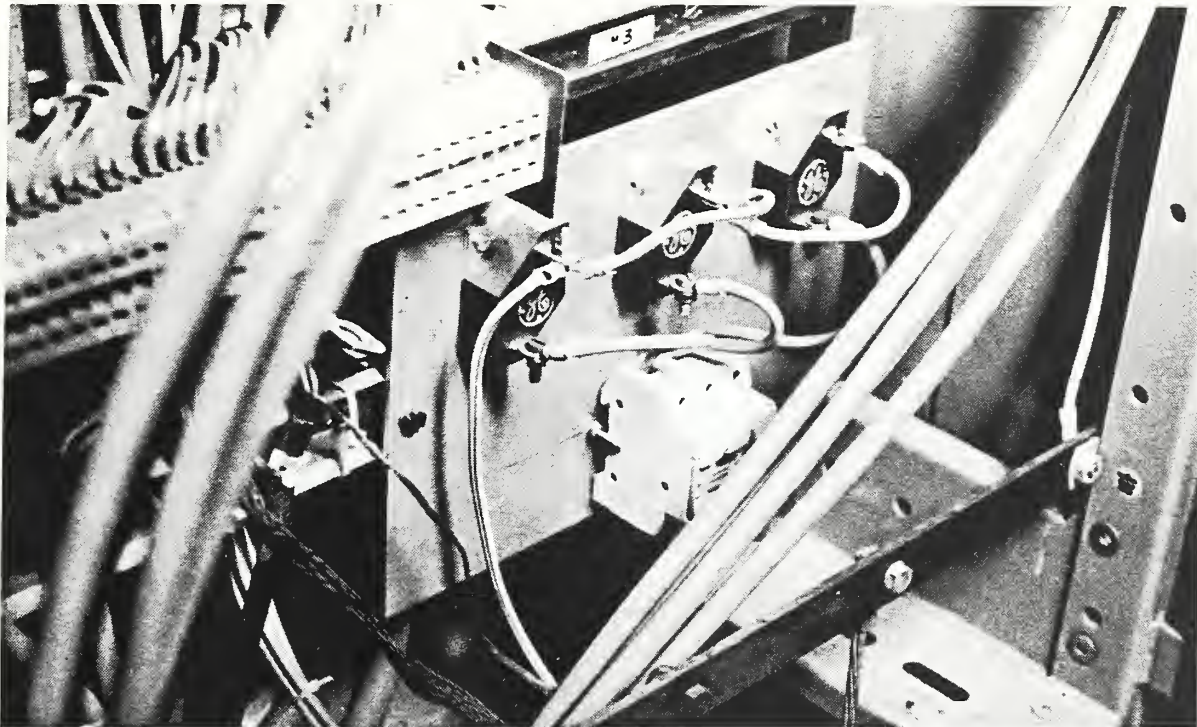
2-10 and 11 Varistors at ac input of inverter

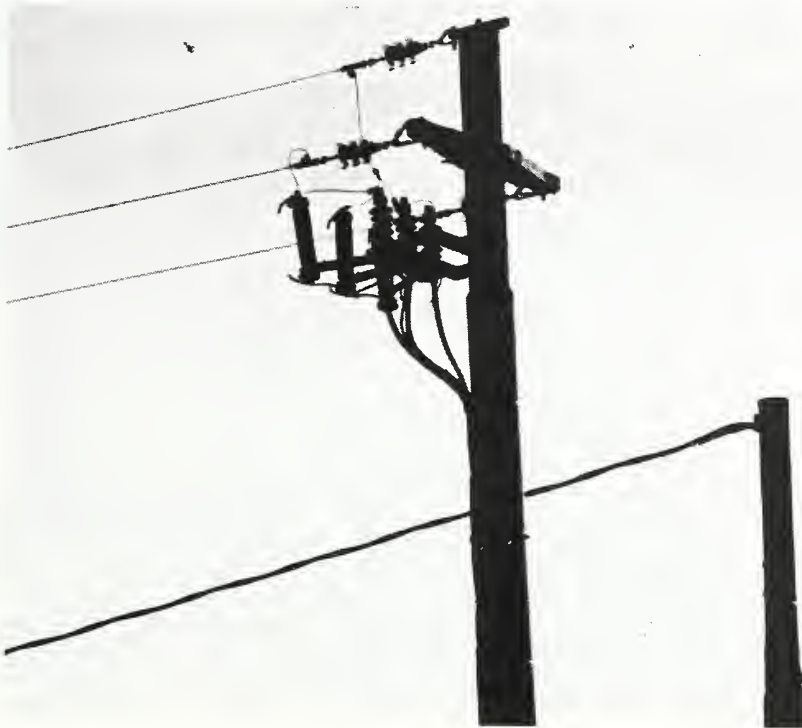
2-13 Surge arresters at 20 kV interface

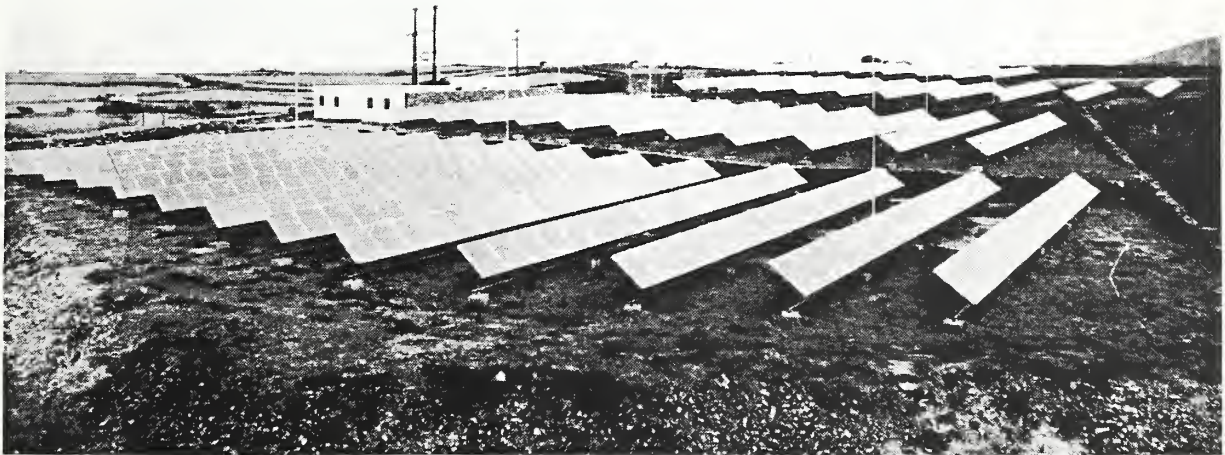
2-15 Relative elevations of upper and lower edges of the panels

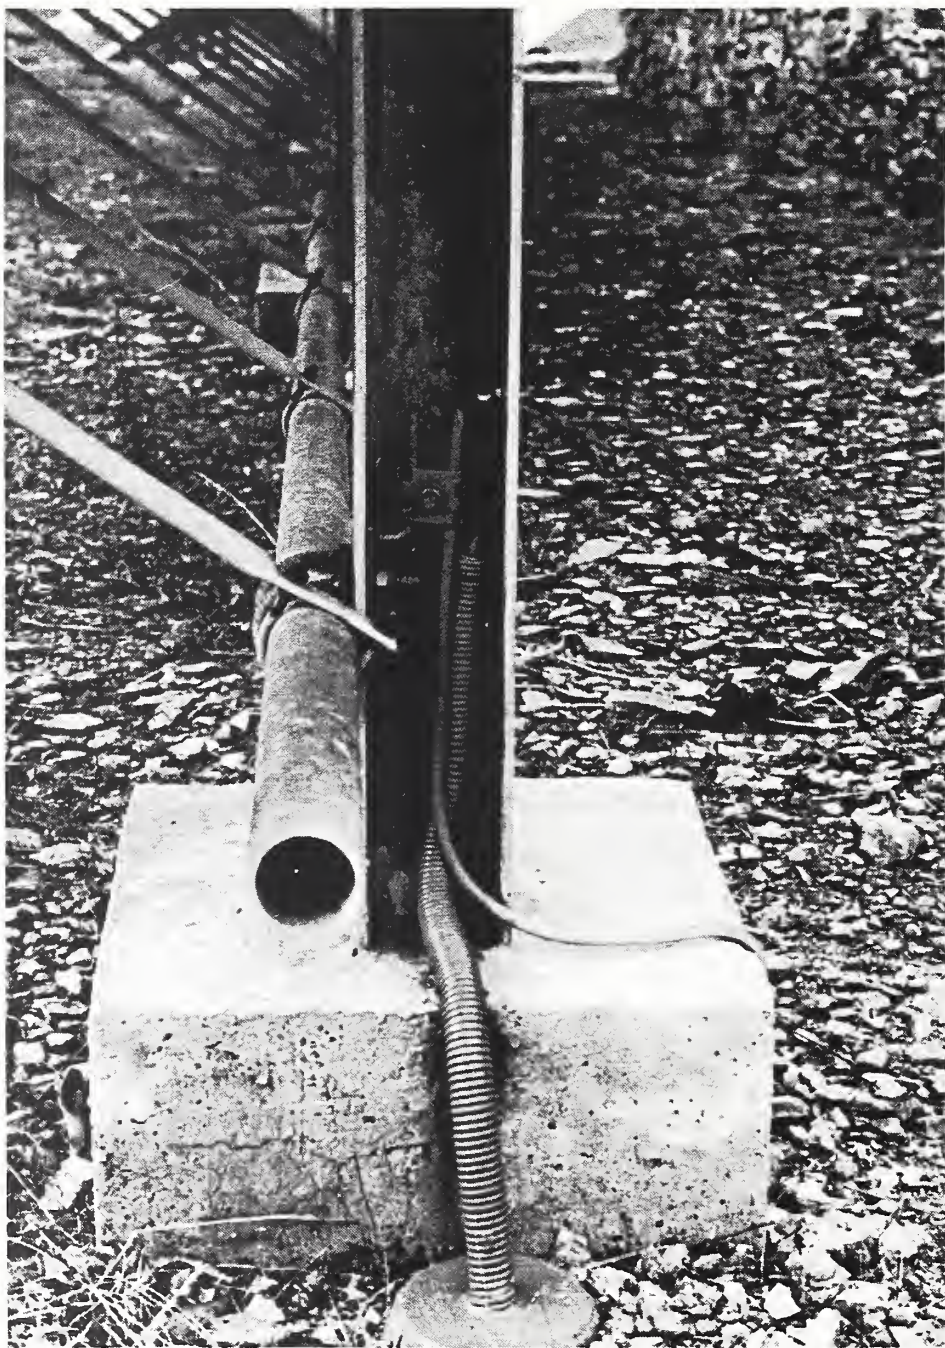
3-4 Grounded footing of array column

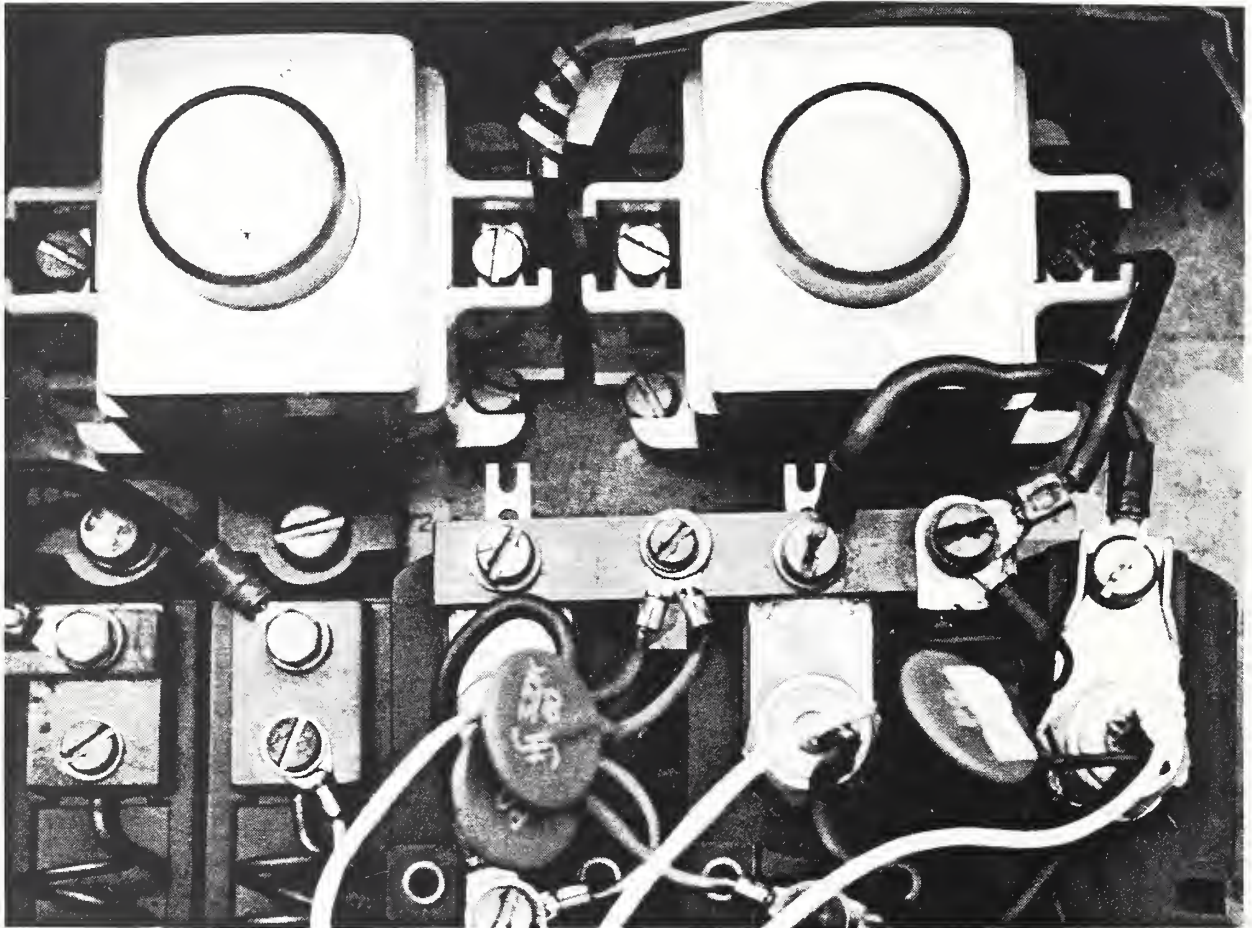
3-7 Typical terminal box for 3-string combination
Top: surge arresters connected (+) to earth and (-) to earth
Center: blocking diodes for 3 strings

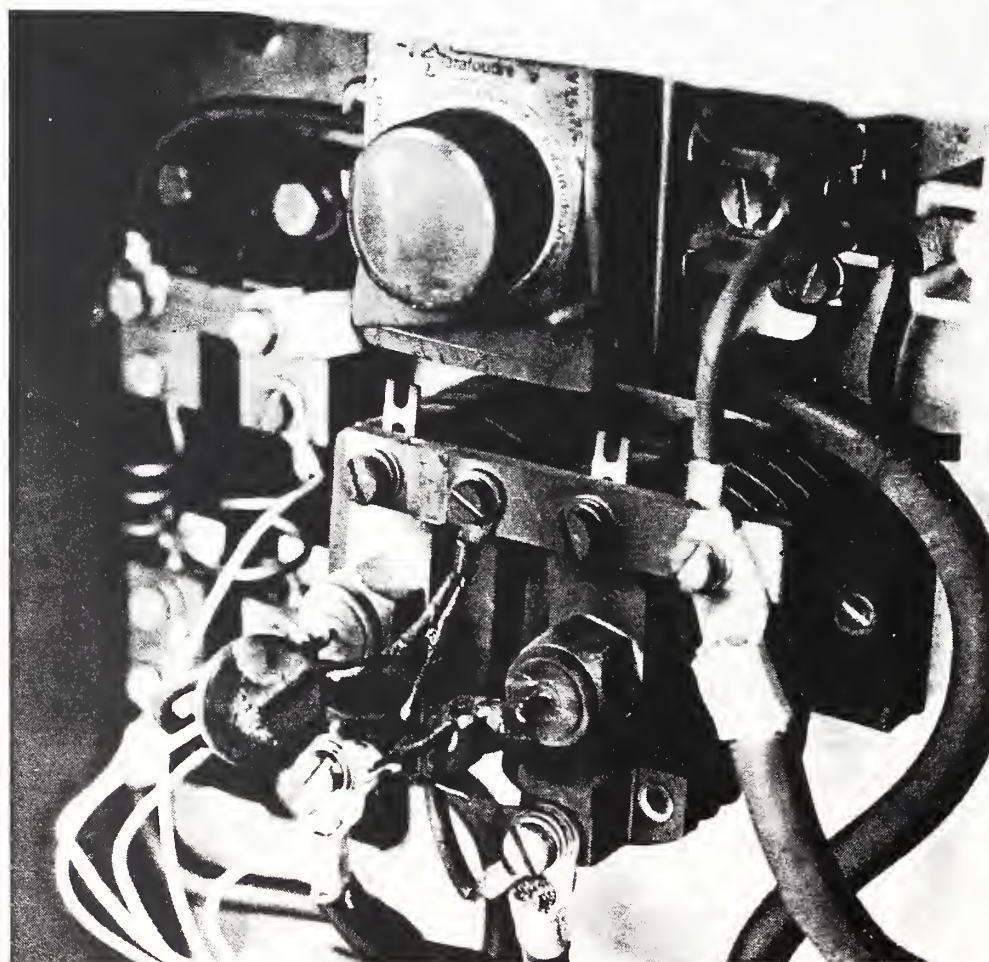
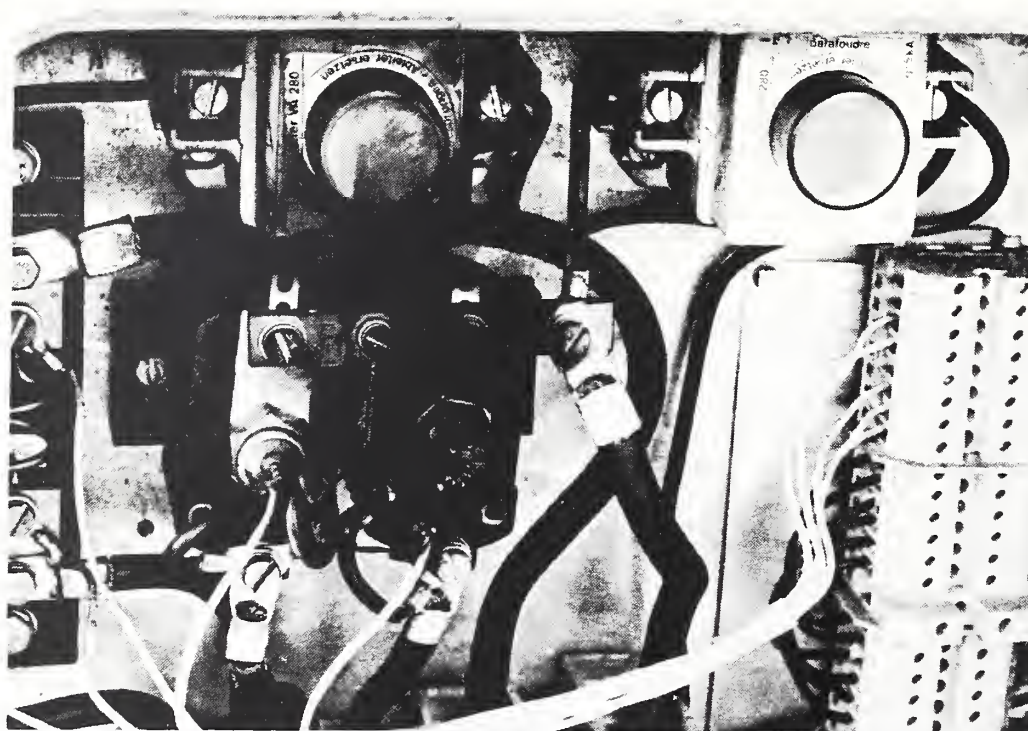
3-9 Terminal box damaged after February 4, 1987 incident

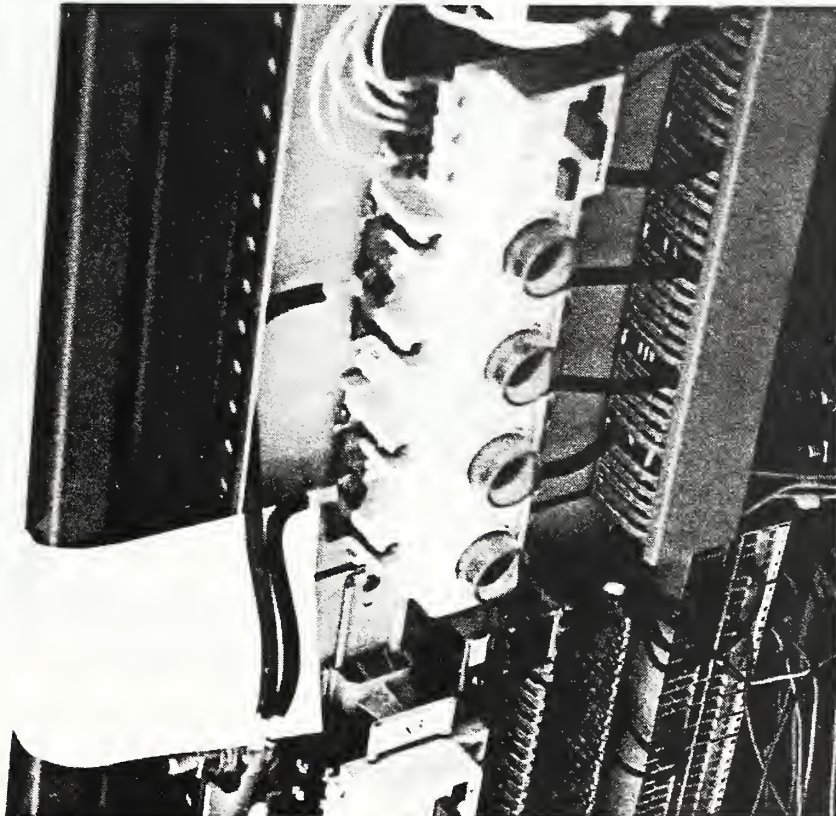
3-13 Surge arresters at ac interface

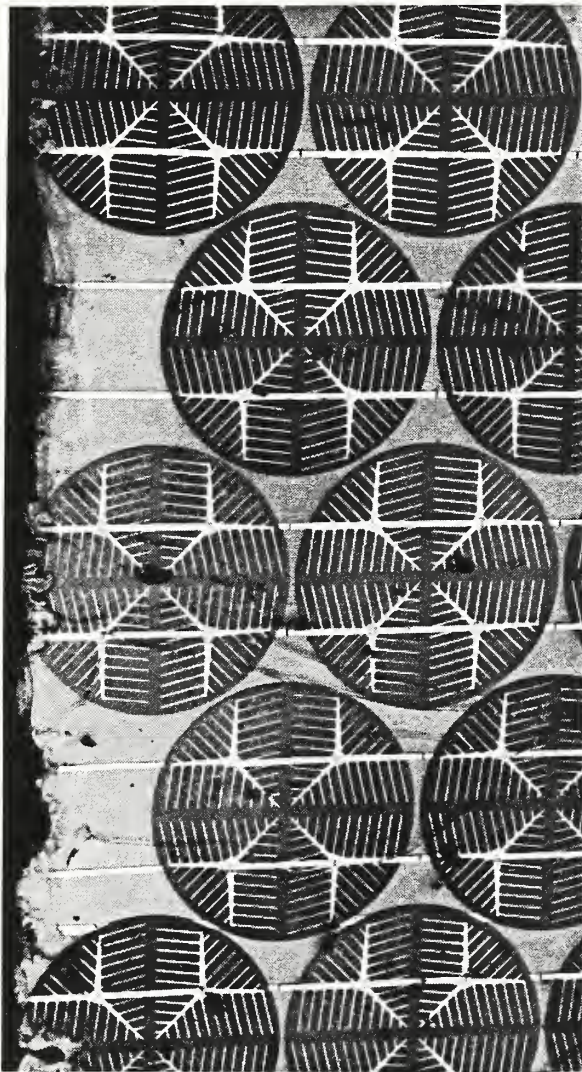
3-16 MODULE-307 0423 - Note burn marks at upper left
and lower right edges

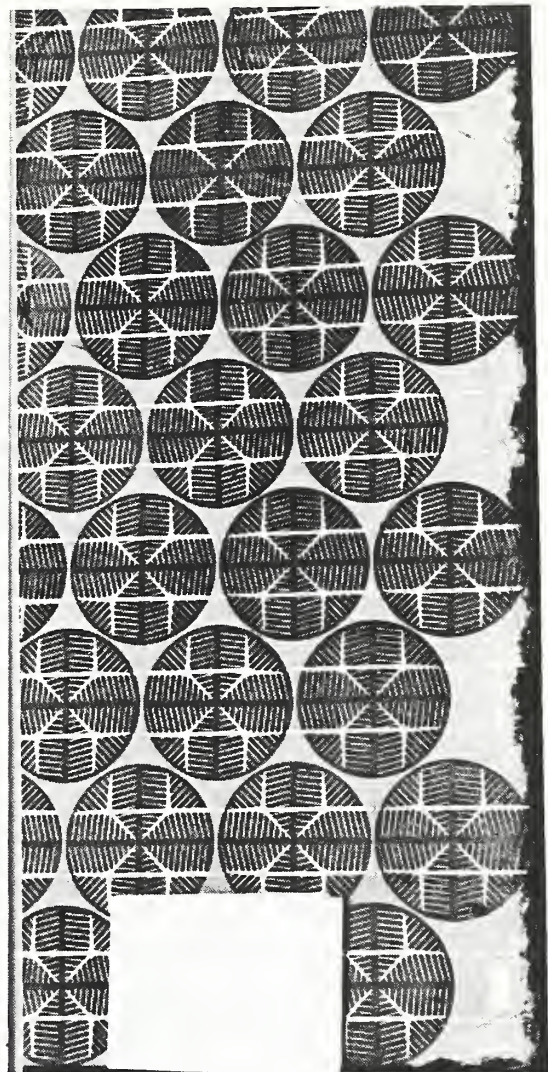
3-18 Details of burn marks at right

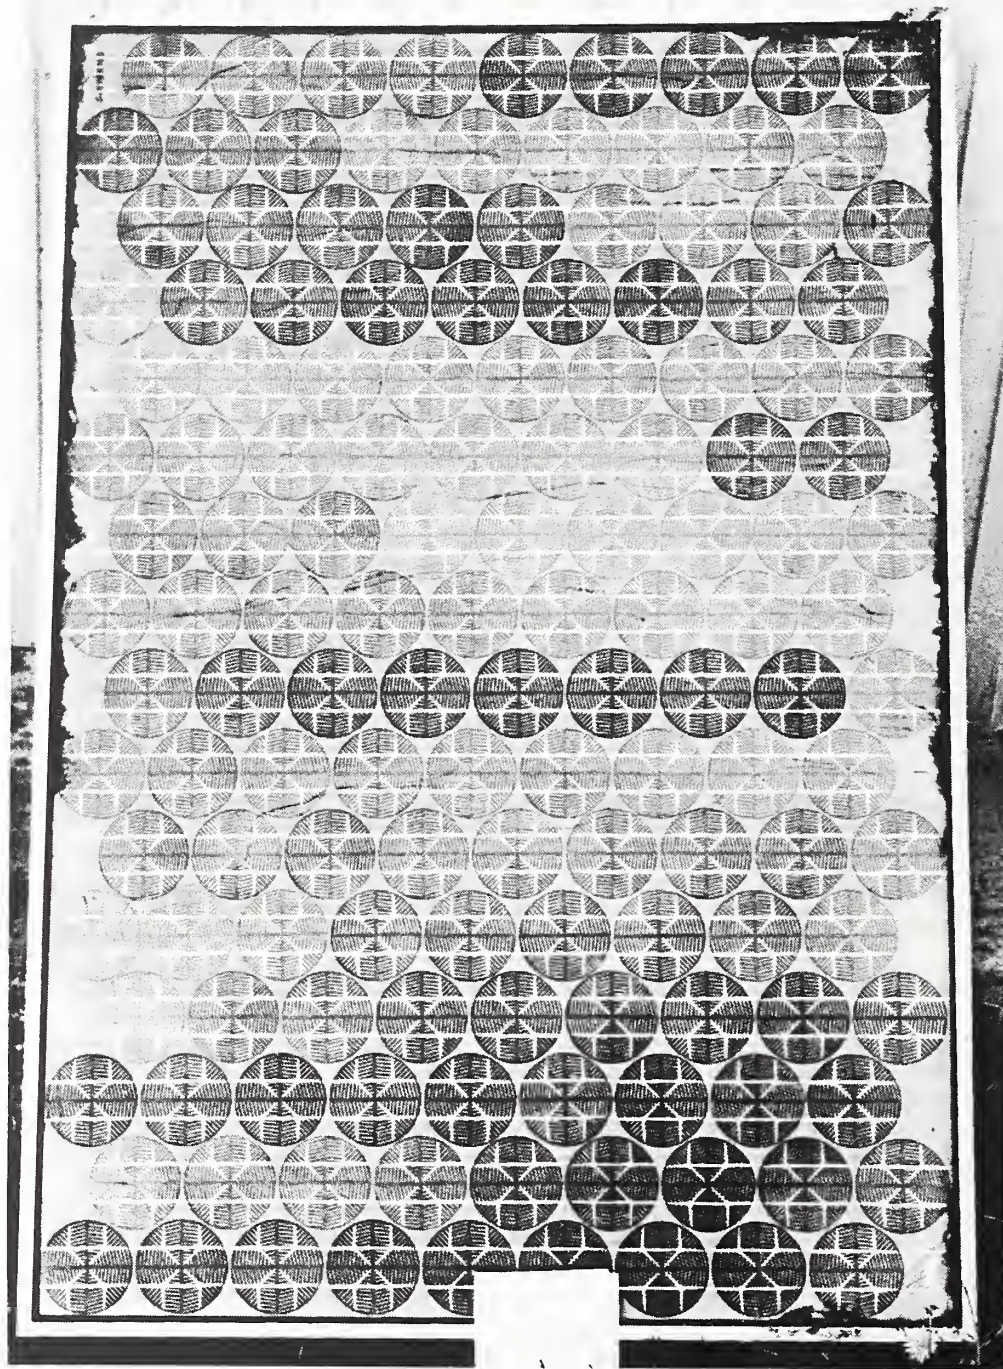
3-19 Detail of damage at top corner

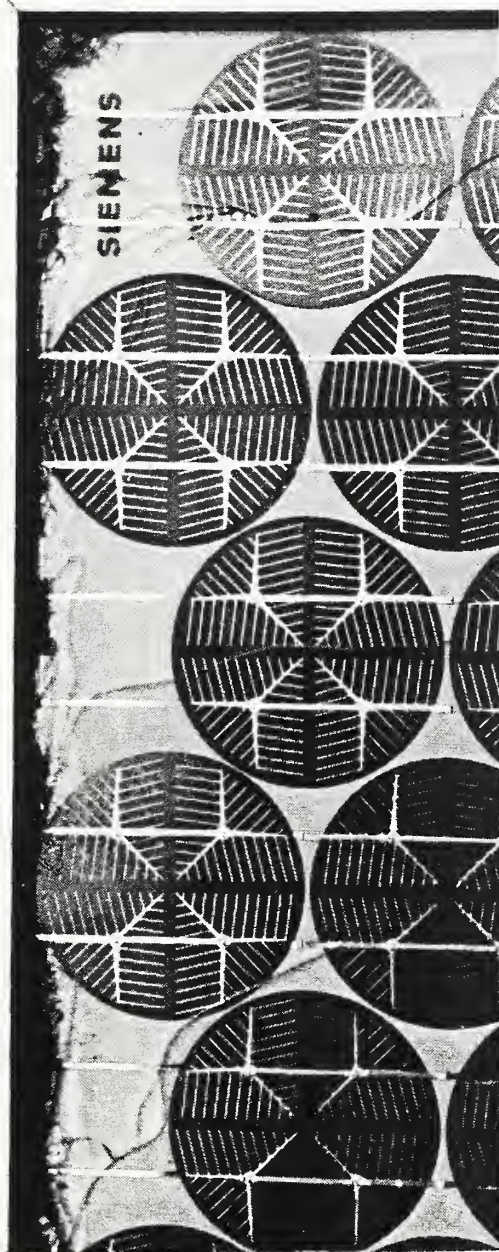
3-20 MODULE-303 0267 - Note burn marks at vertical edges and corners

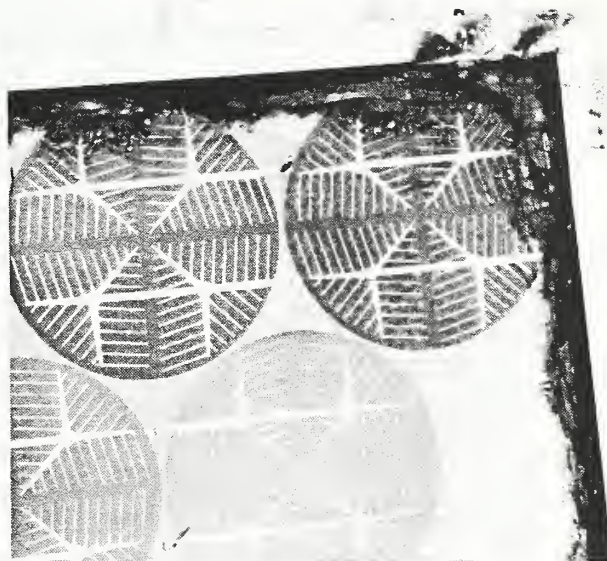
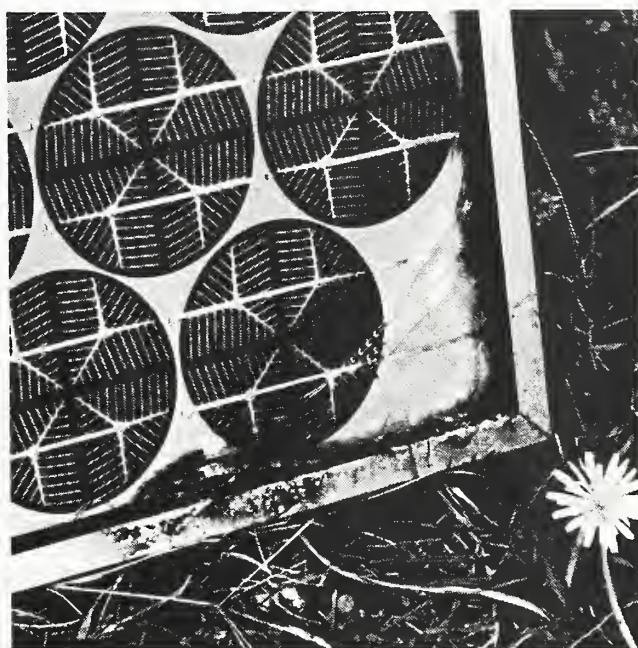
3-21 Detail of heavy burns at top corner

3-22 Detail of burn at bottom corner

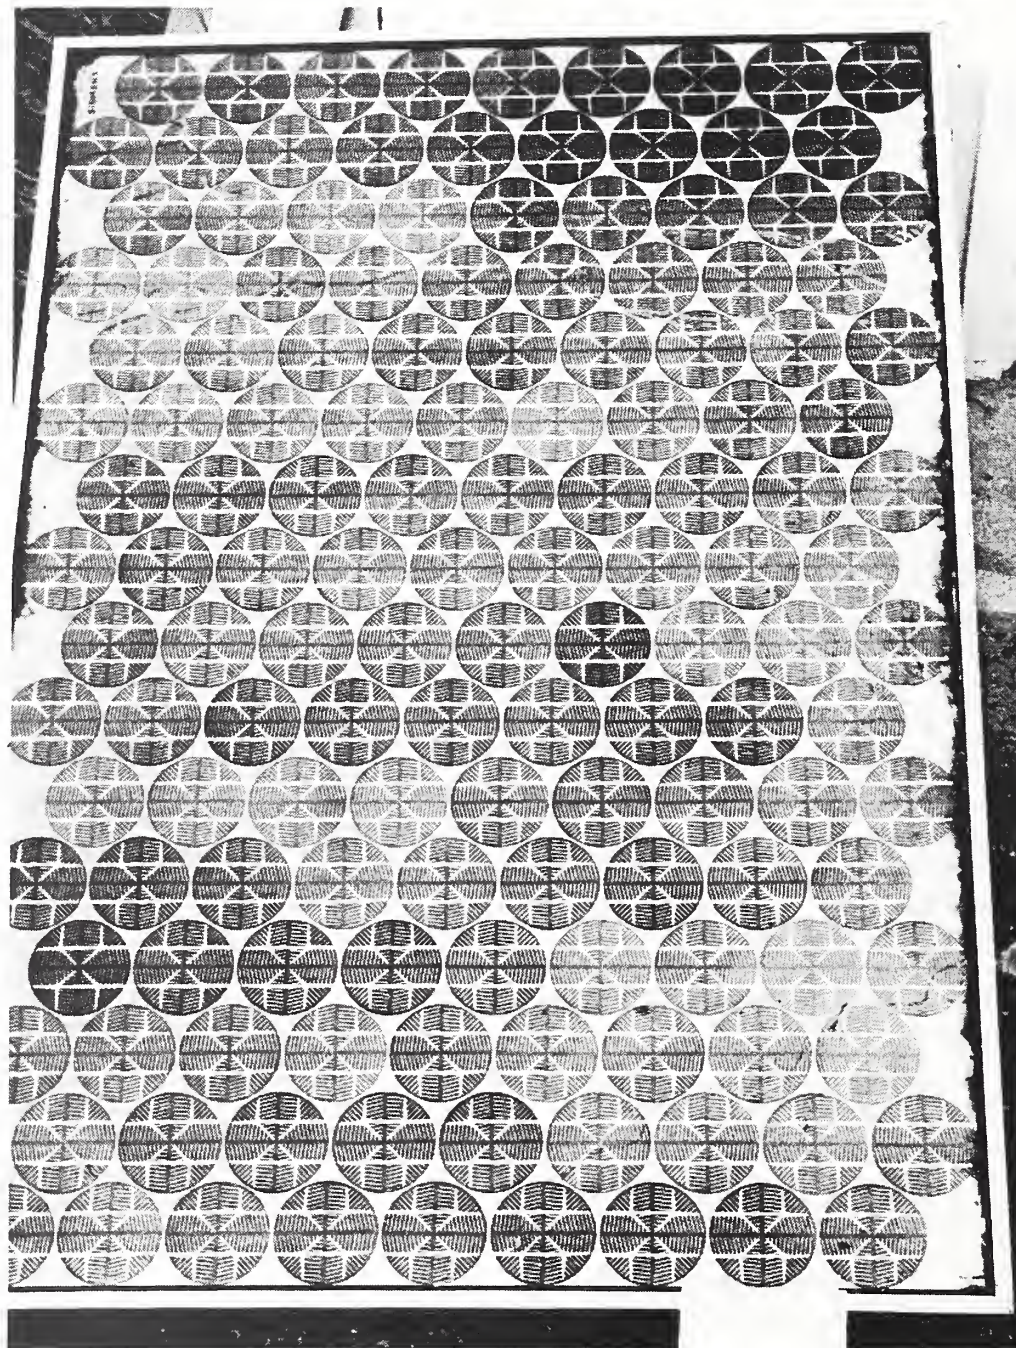
3-24 MODULE-304 0294 - Note burn marks on edges,
little damage at corners

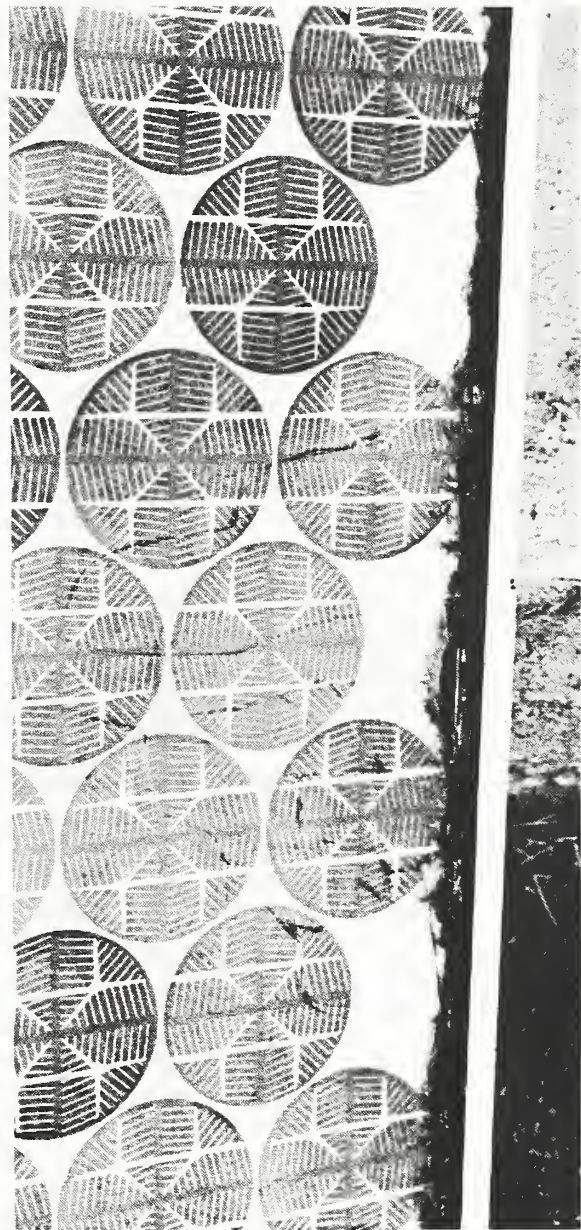
3-27 Detail of right edge

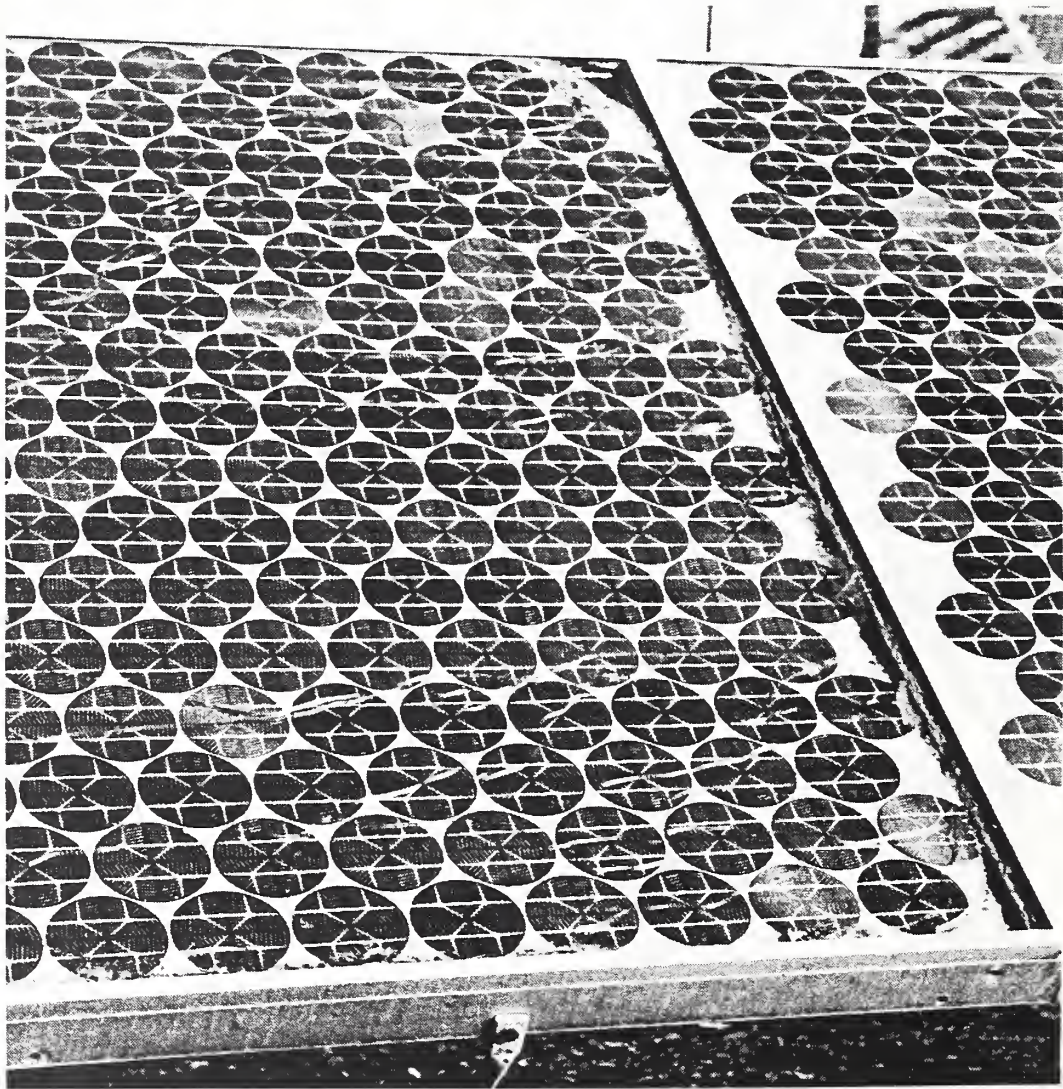
3-26 Detail of top left corner

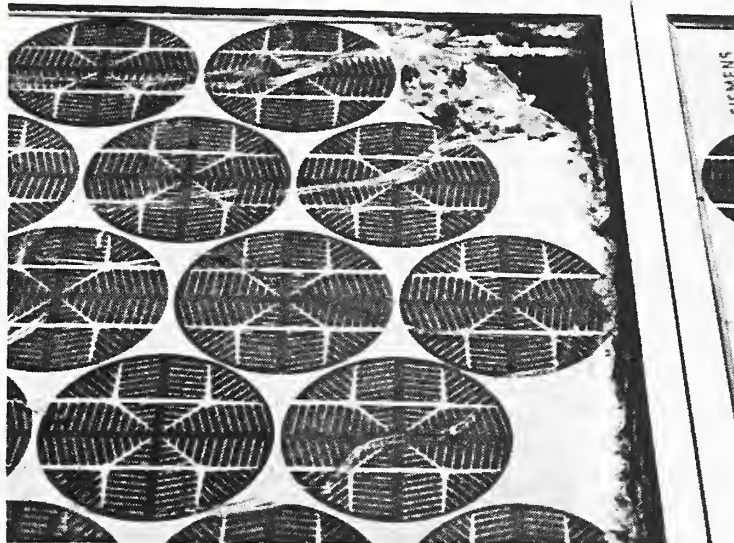
3-28 MODULE-306 0417 - Module left in array - Damage at right edge

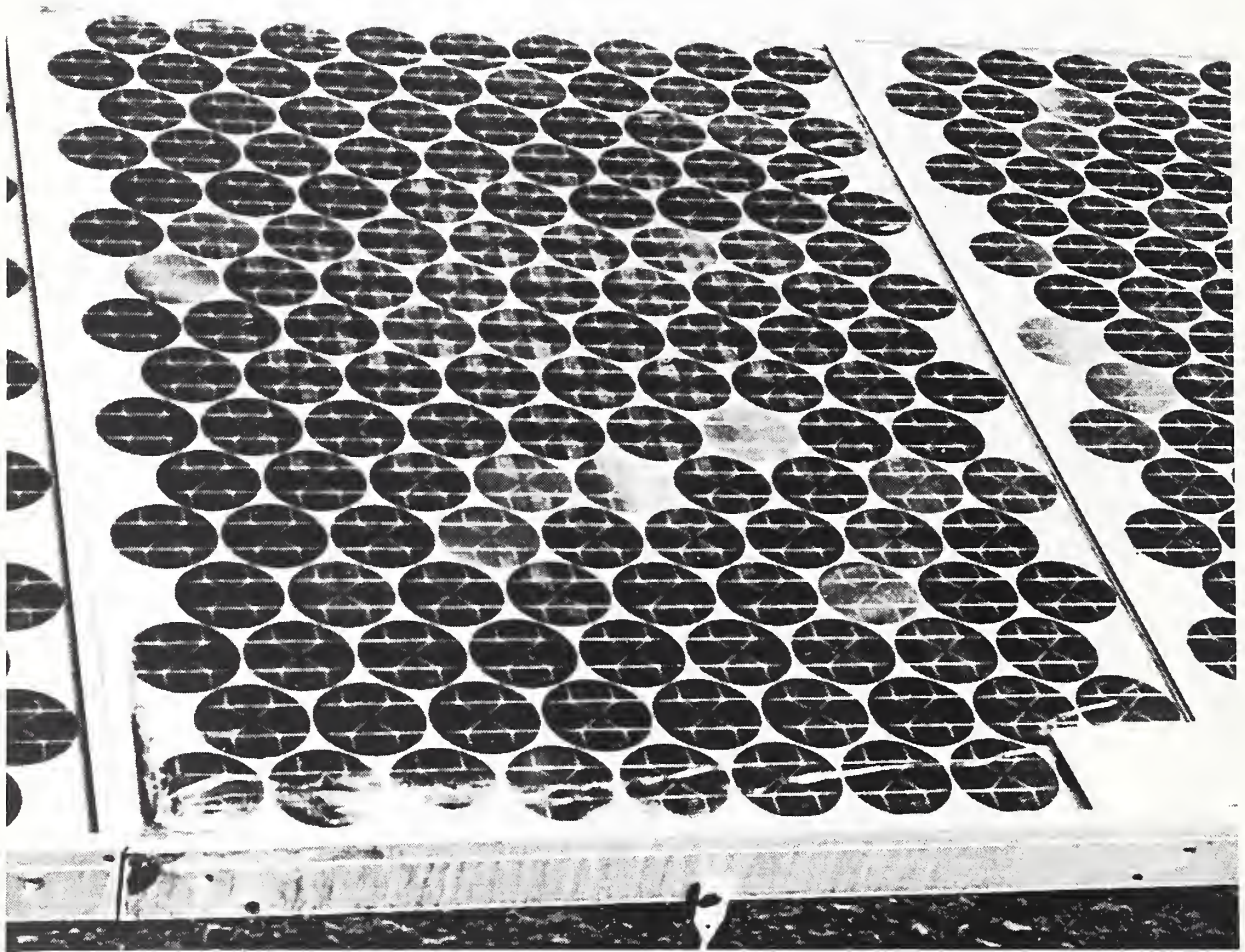
3-30 Detail of bottom right corner

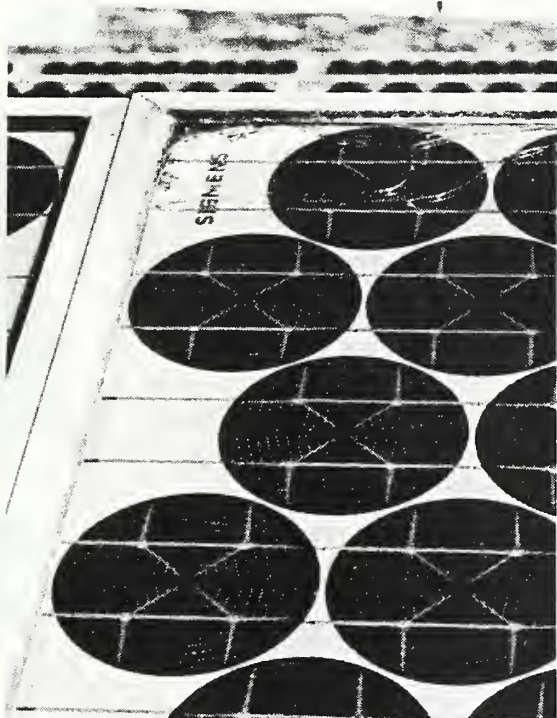
3-31 .MODULE-304 0300 - Damage mostly at corners

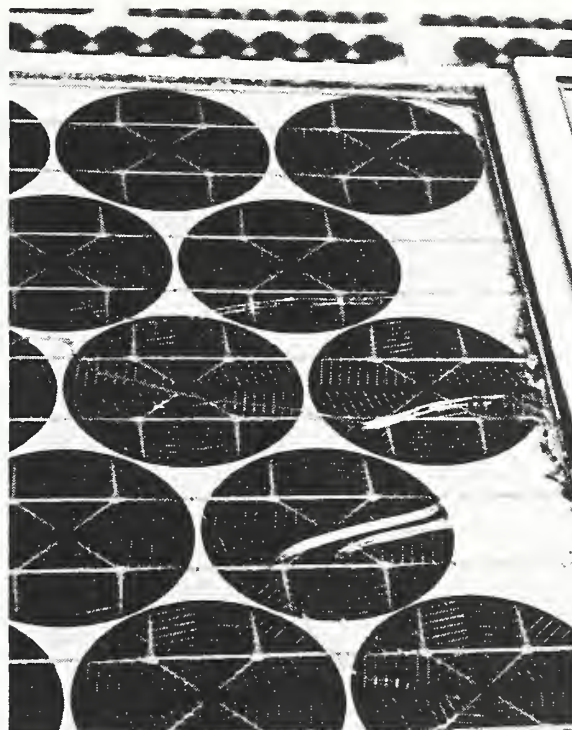
3-33 Detail of top right corner
